An Explanation of Chirp in High Frequency Transmission Line Transient Response

By John Addis

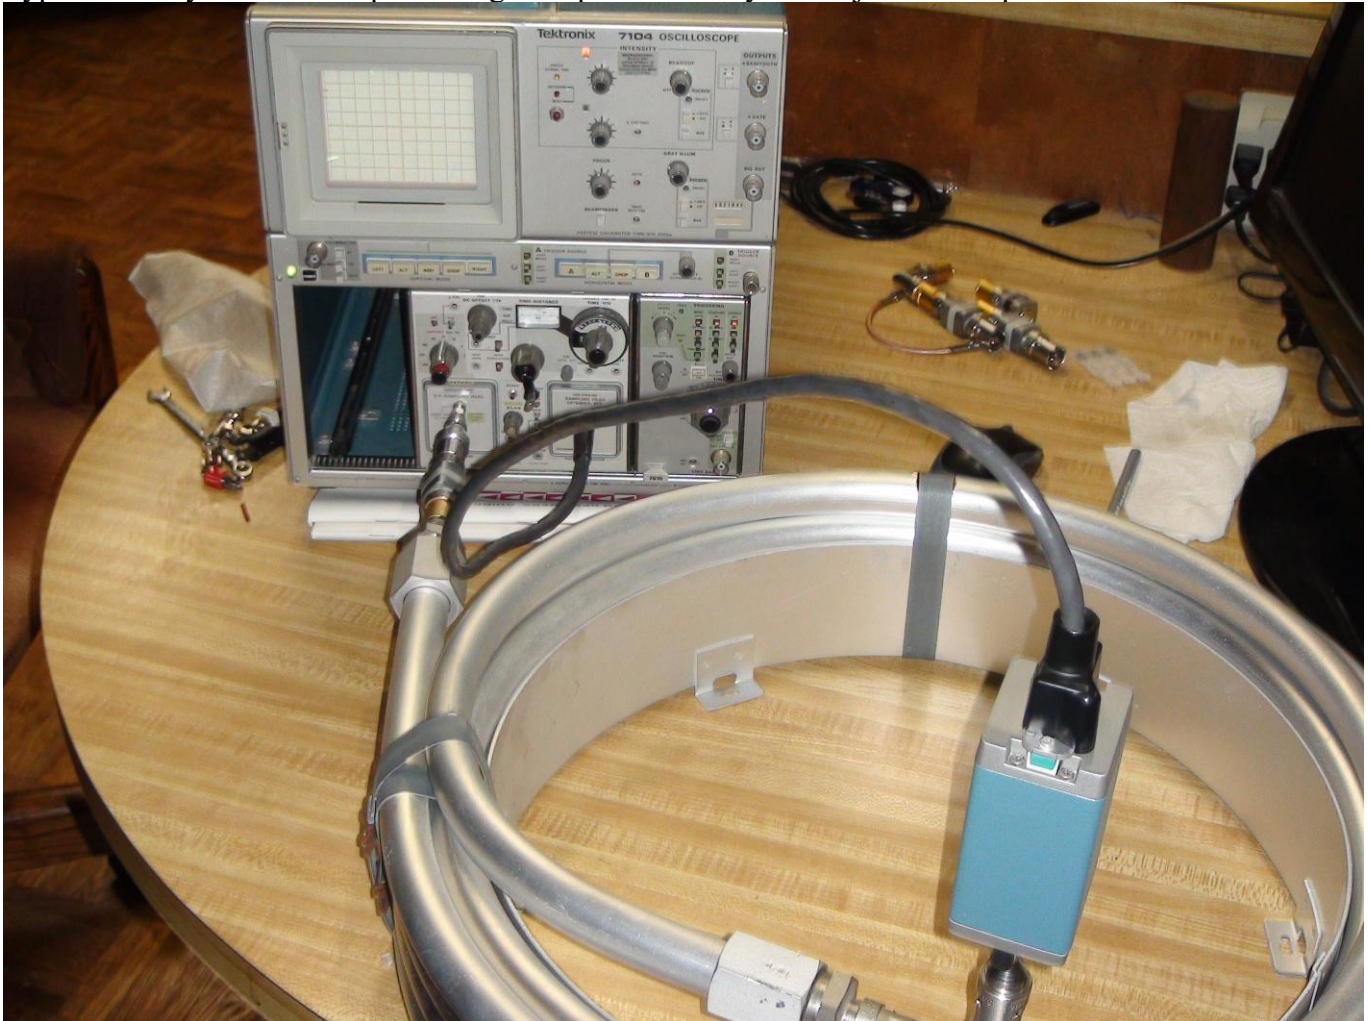
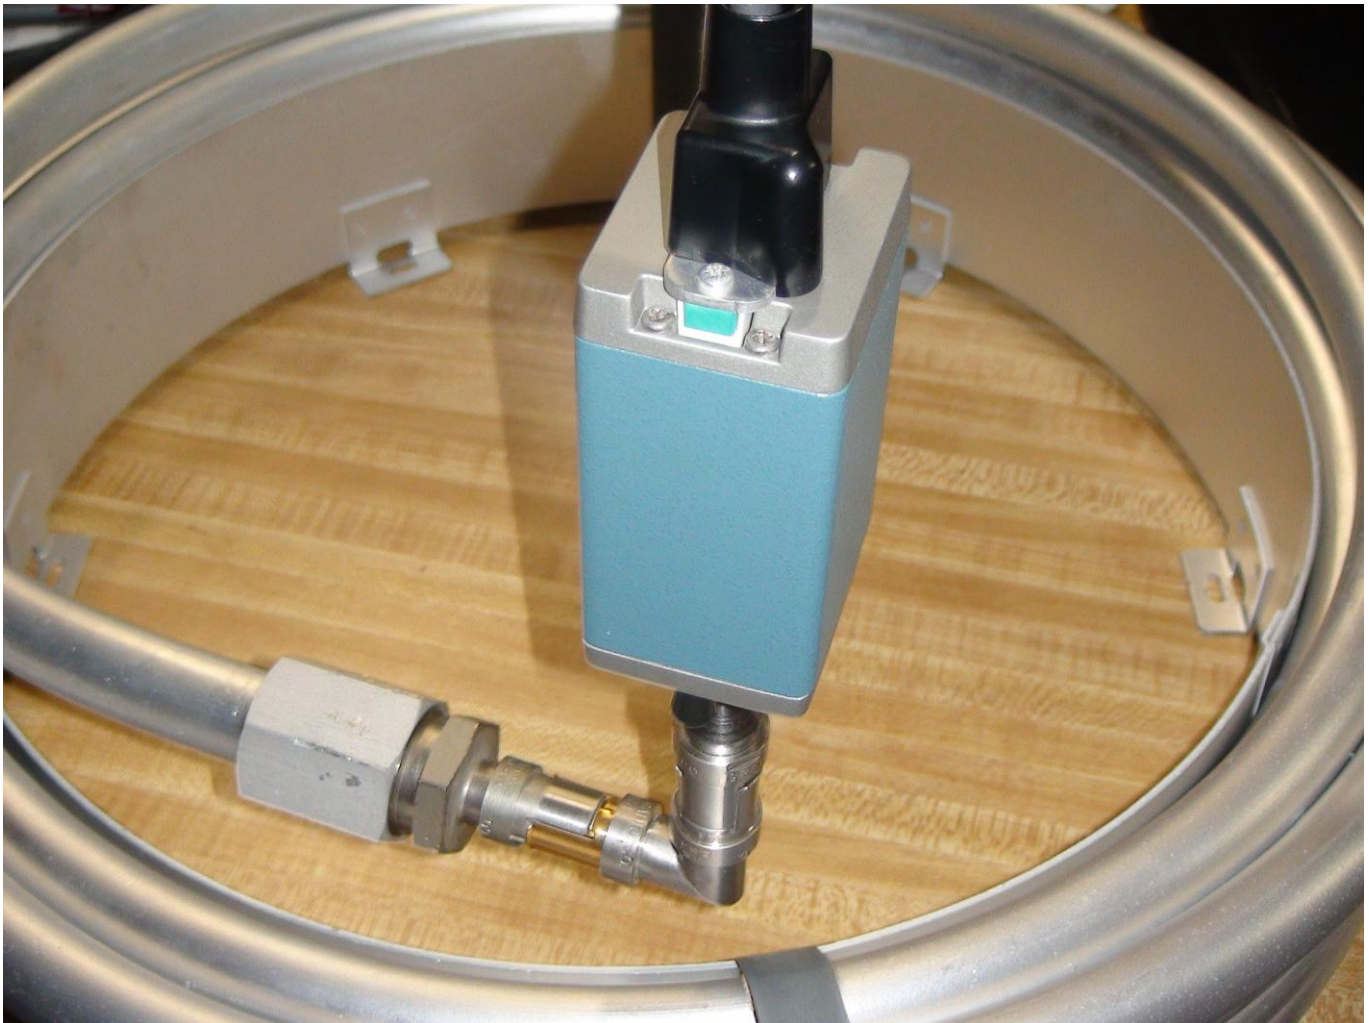
The input of the signal path detail shows the S-52 pulse generator on the end of an extension cable. From the S-52, the signal goes through an SMA to GR 50 ohm adaptor, then to an elbow 50 ohm to 125 ohm adaptor and into the test cable. Gold outer conductor means the connector is a 125 ohm impedance. However, in this case, there is no matching resistor inside the elbow, so there is a reflection at this junction, but the signal amplitude is not attenuated.

The output of the signal path detail shows a GR 150 ohm to 50 ohm impedance match unit connected to the delay line. To its left is a 50 ohm GR to BNC adaptor and off to the left is a BNC to SMA connector to the S-6 sampling head's SMA input.

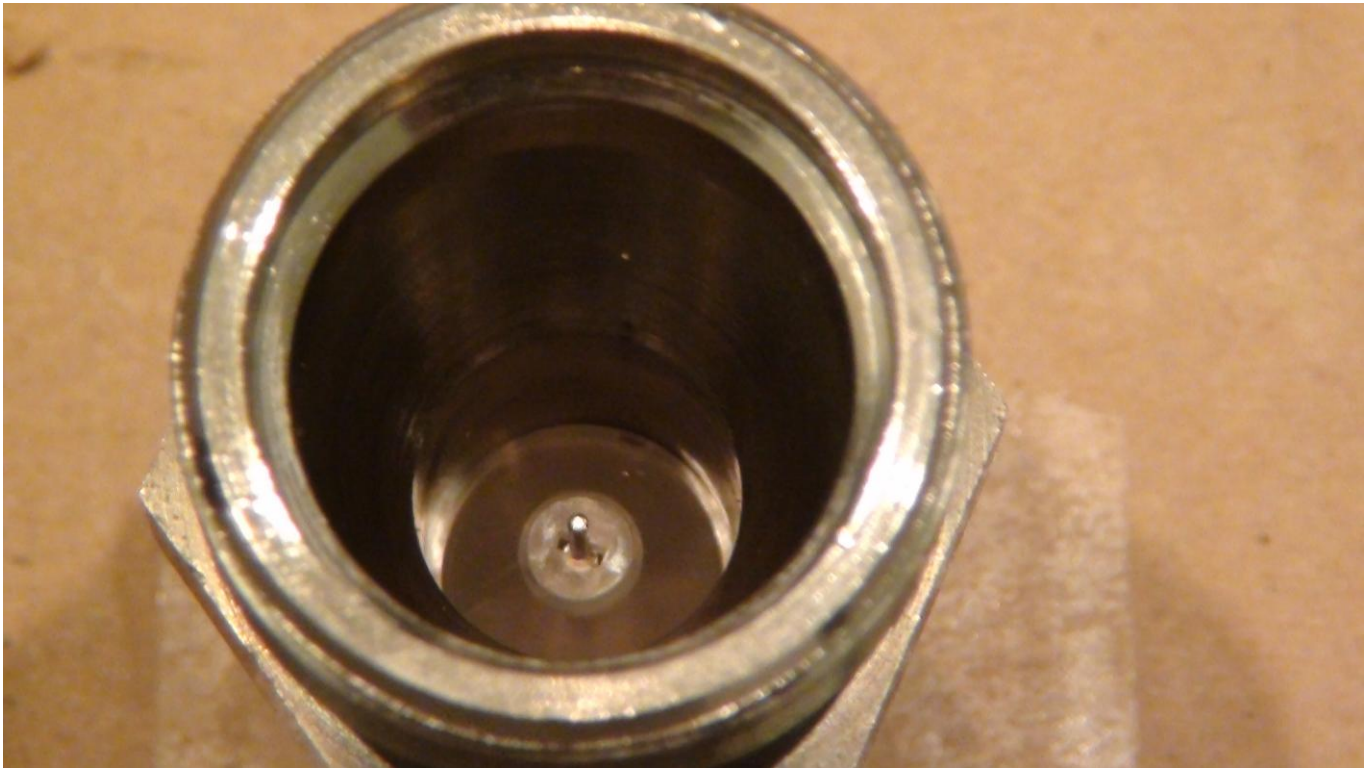
The center conductor had moved/shrunk by something like a $\frac{1}{4}$ inch and the sliding center conductor was no longer reaching the short pin inside the GR connector, shown below.

I heated up the 1 inch long piece and pulled on it. It came out about $\frac{1}{4}$ inch but still stayed soldered to the center conductor.

I reassembled the connector and tested the connection with the Time Domain Reflectometer (TDR) configuration of the 7S12/S-52/S-6. It worked.

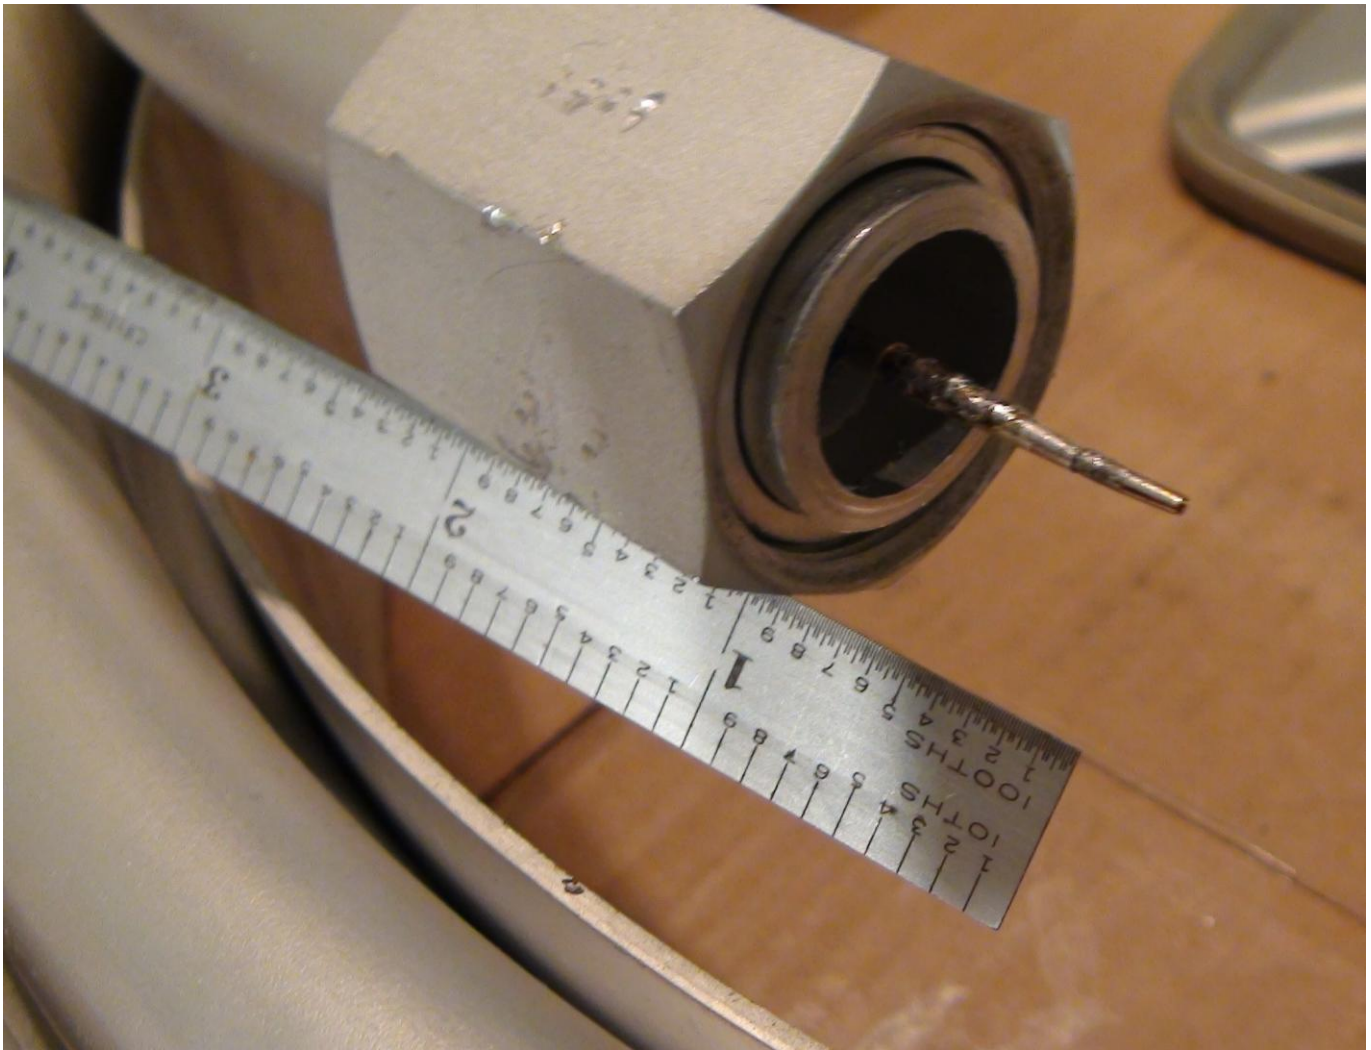
Below: The center conductor is soldered to a 1 inch long piece, tapered in diameter to match the connector's tiny part of the GR's 125 ohm diameter (at right) which slid into the one inch long piece (center) that had a tiny spring socket at its end (extreme right).

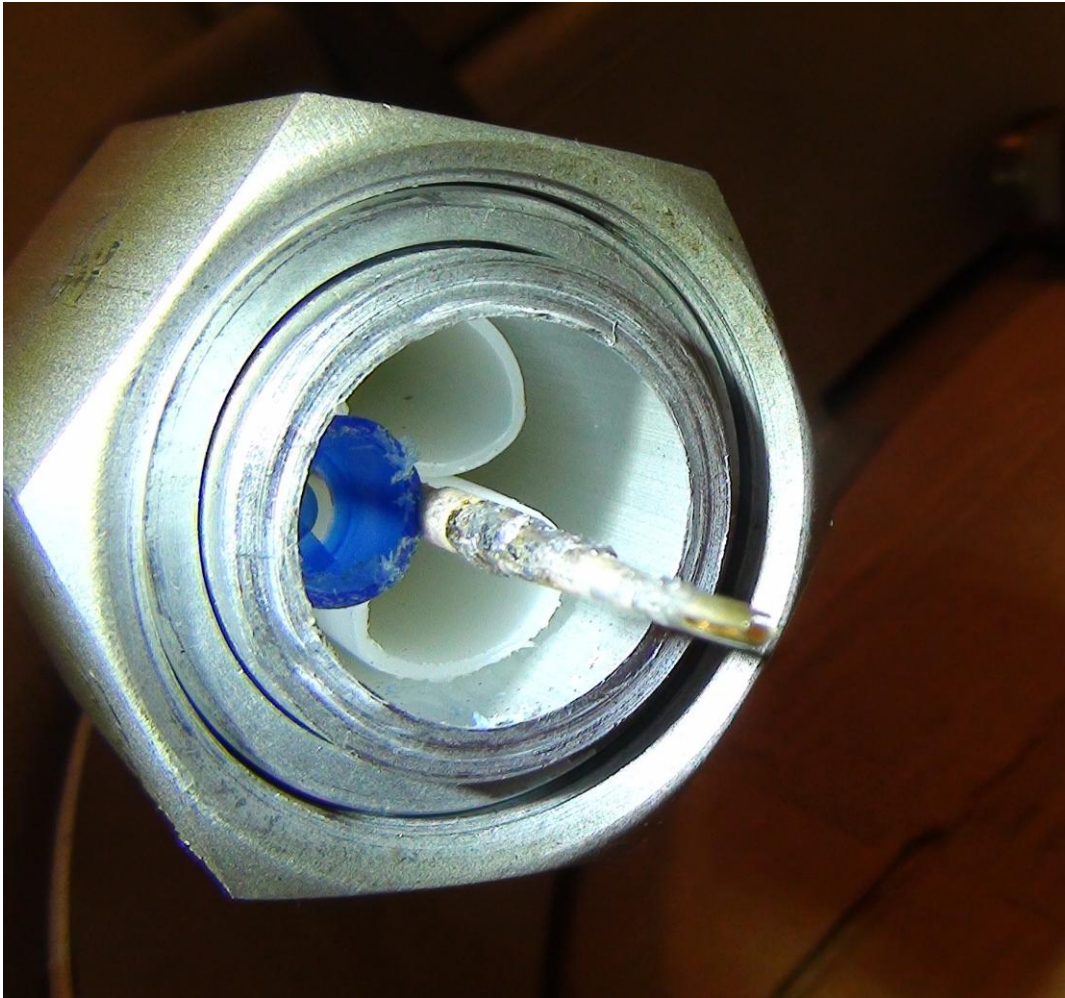
Then I looked at the other end of the 519 delay line with the TDR and found that it too had shrunk, but by even more. Furthermore, the cable was no longer centered. One of the three polyethylene tubes had shrunk more in length than the others, allowing the center conductor to move off center. I cut the top off a blue ball point pen cover and shoved it down in place of the shortened tube, as seen in the picture below.

It took hours (and 130V input to the soldering iron) to pull the one inch adapter piece out about 3/8". With each attempt, I made detailed measurements of the amount of the center conductor's extension and the distance the GR's center pin was recessed using calipers until I got the two to match and contact. This took days!

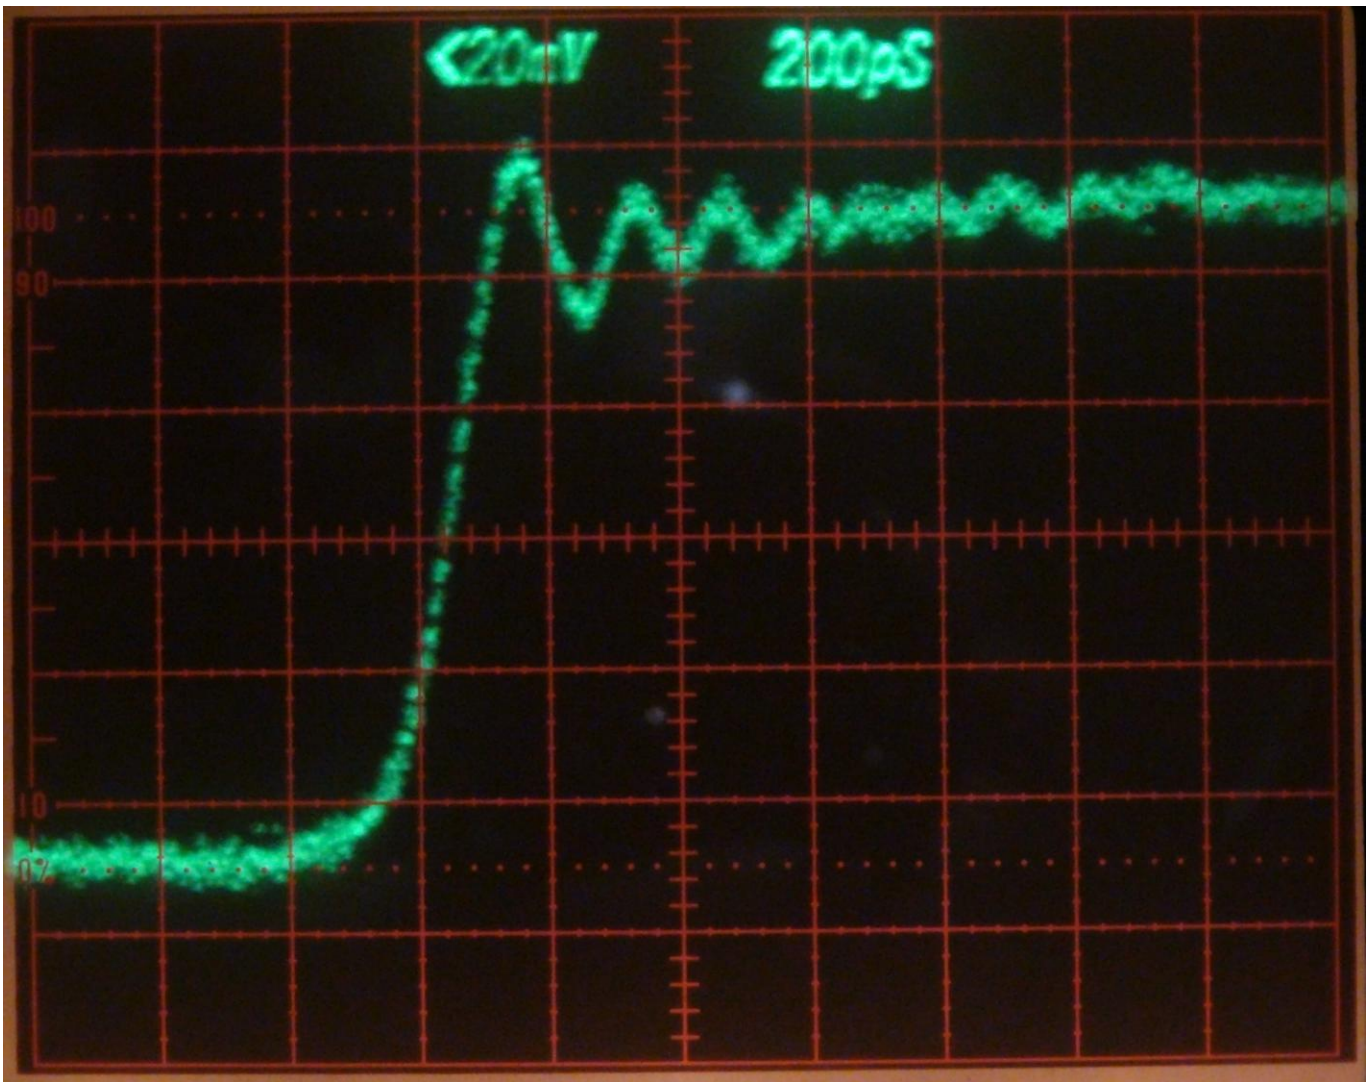
With both ends matched (a second 50 ohm to 125 ohm impedance matcher now inserted between the S-52 pulser and the delay line), this is the observed transient response, with a 165 ps rise time:

There is an obvious ring, but is there a chirp (ring frequency change from left to right)? A careful count of the period of successive rings does appear to show a chirp. The fact that the chirp does not last long should not be too surprising. The higher skin effect loss in the Type 519 delay line attenuates the ring much more quickly than that of the Type 113 suitcase transmission line. The skin effect loss is apparent in the slow rollup of the pulse's vertical center (about half a division from the initial pulse to the right side of the picture).

The trace's blur between the fourth and fifth cycles seems to imply that the line's ring frequency interferes with and cancels a ring in the transient response. This is apparently the reflection off the line (or the elbow) and back to the S-52, that is not a very clean reverse termination.

The noise in the trace is due to the significant signal attenuation of the two impedance matching units.

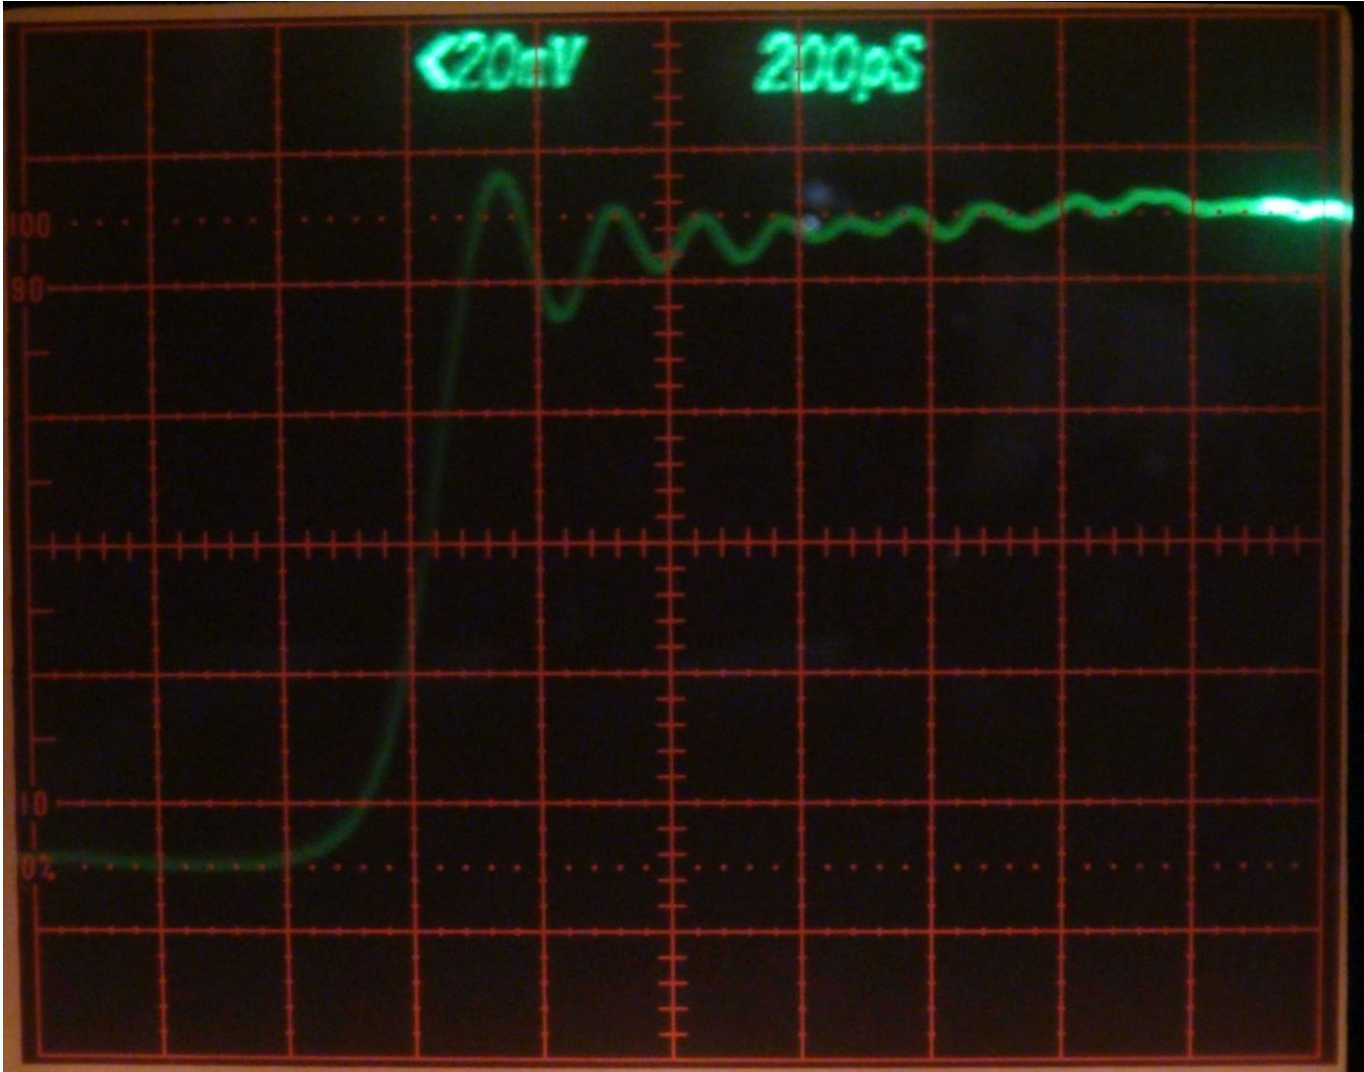
An additional photo was take without any matching network installed between the S-52 and the delay line. This produces less noise and does not seem to change the signal significantly. (The sensitivity is less even though the readout still indicates "<20mV" per division.) The rise time is still about 165 ps

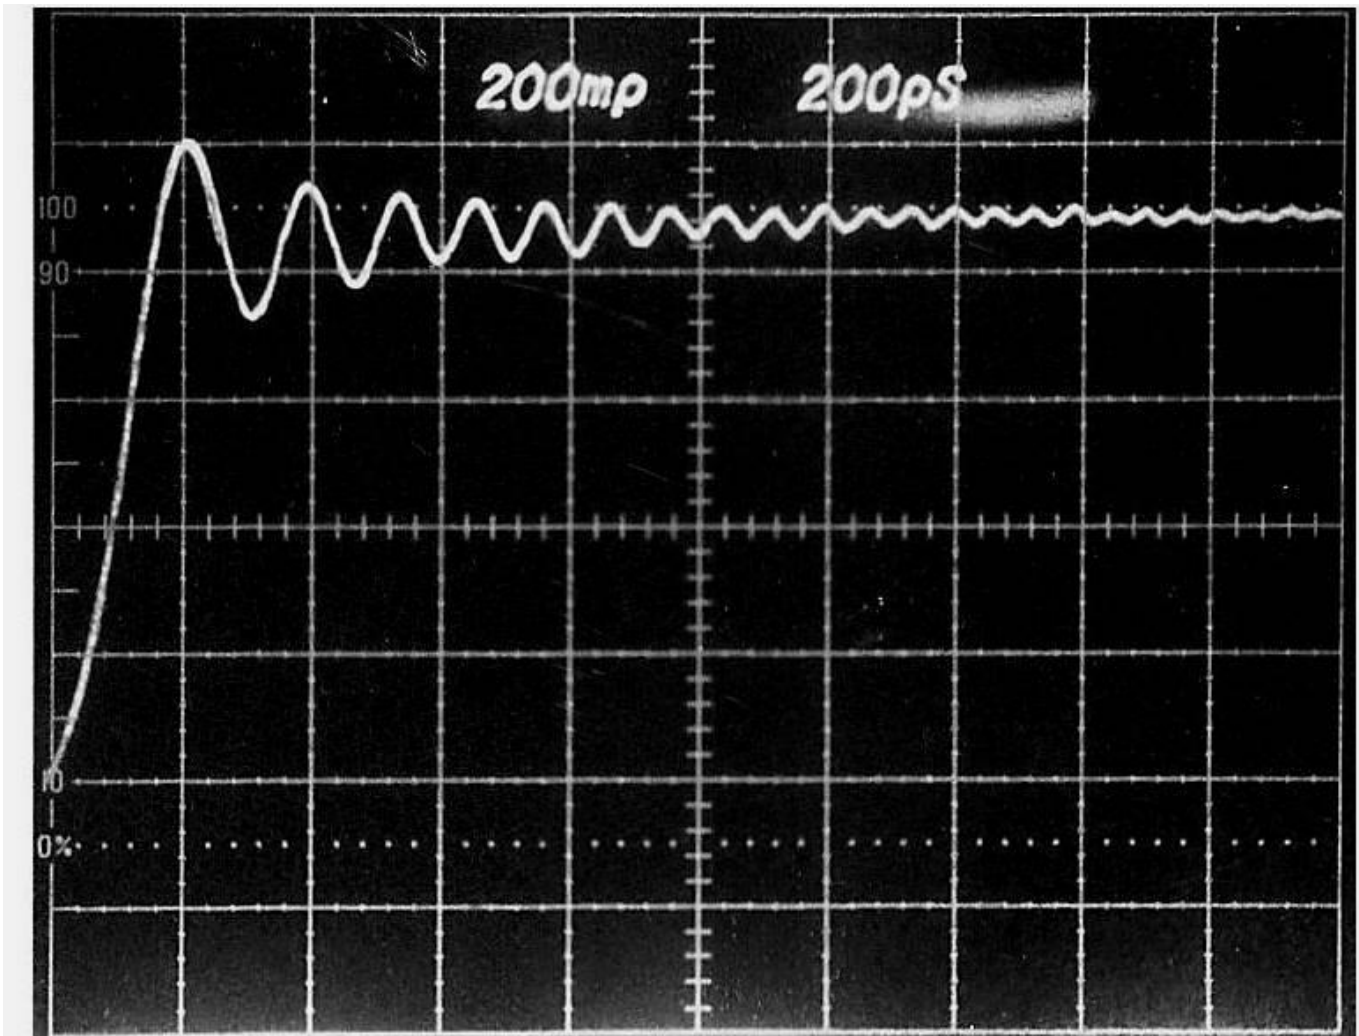
Tektronix Type 113 Delay Line ("Suitcase") transient response in S52/S6 Sampling System (using cable extenders). System BW is about 11GHz (32ps). The ring, never known until samplers and perhaps never measured until this photo, is most likely due to moding in the large diameter line. Skin effect is barely detectable (due again to 7/8" diameter line). Chirp is about 16GHz at right and 8.3 GHz at left. John Addis 9/27/1989

Conclusion: Although there is less chirp in the Type 519 delay line, this can be explained by the much (≈ 6 times) greater skin effect loss in the Type 519 line that has a much smaller diameter center conductor essential to obtaining the 125 ohm characteristic impedance. Although less apparent, there is still a chirp in the Type 519 delay line. I conclude that the chirp is caused by the polyethylene's dispersion.
