An Explanation of Chirp in High Frequency Transmission Line Transient Response

By John Addis

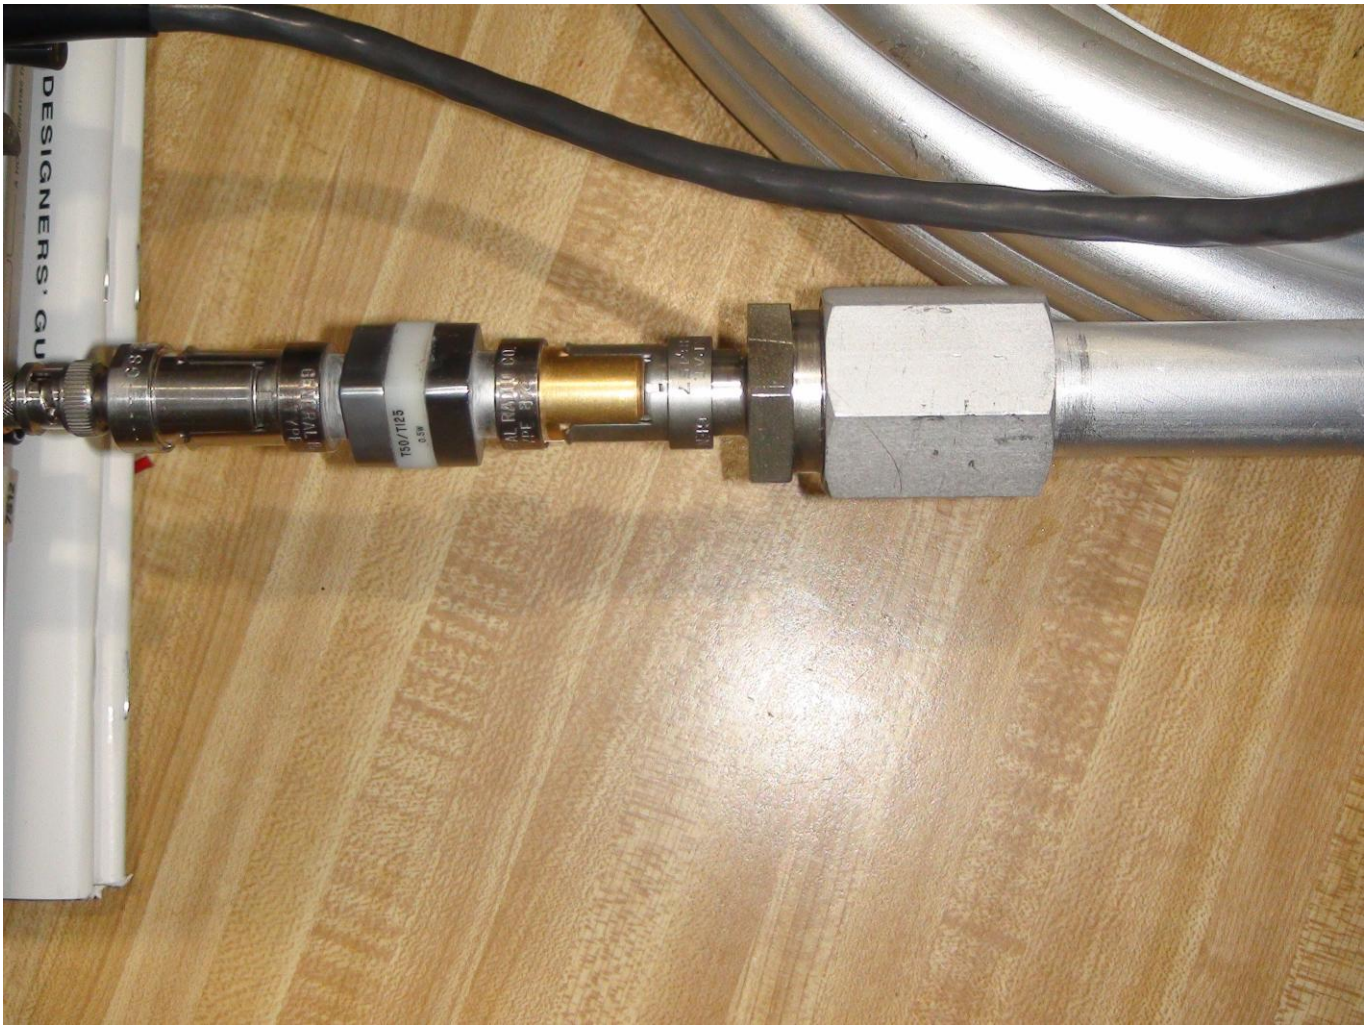
The output of the signal path detail shows a GR 150 ohm to 50 ohm impedance match unit connected to the delay line. To its left is a 50 ohm GR to BNC adaptor and off to the left is a BNC to SMA connector to the S-6 sampling head's SMA input.

Upon making all of these connections, I got no signal displayed on the scope.

After testing each of the interconnections and confirming that the S-52 works into a 125 ohm load, I checked the very last part of the signal path, the 519 delay line, which turned out to be open. But where? Oh, wait, I have the perfect equipment to find out exactly where it is open! And the output end was open at the connector, so I disassembled the connector. (The output end refers to the output in this setup, although it is actually the input end of the line when installed in the 519.)
